# New Hampshire Volunteer Lake Assessment Program

## 2002 Bi-Annual Report for Clement Pond Hopkinton

NHDES  
Water Division  
Watershed Management Bureau  
6 Hazen Drive  
Concord, NH 03301

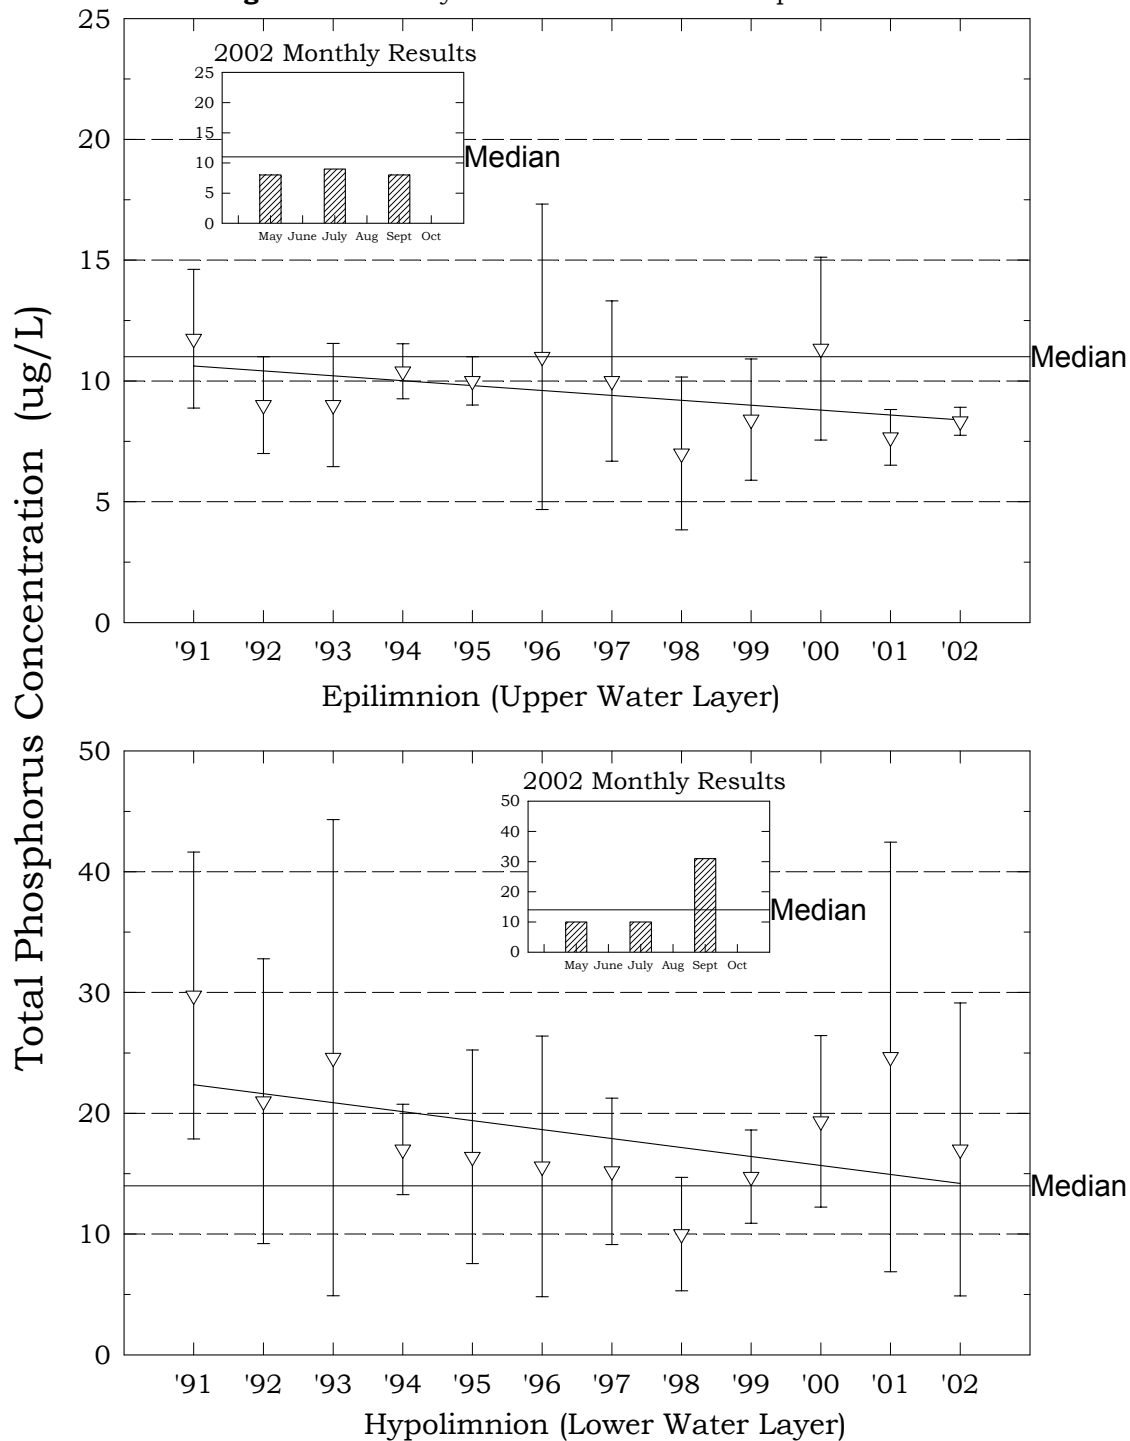
**Figure 3.** Monthly and Historical Total Phosphorus Data.

The current year data for the epilimnion (the top inset graph) show that the total phosphorus concentration **remained relatively stable**, and **less than** the state median, from May to September this season.

The current year data for the hypolimnion (the bottom inset graph) show that the total phosphorus concentration **remained stable** from May to July, and then **increased by a large amount** from July to

September. The total phosphorus concentration in September was **greater than** the state median.

The historical data show that the 2002 mean hypolimnetic total phosphorus concentration is **slightly greater than** the state mean.

Overall, the statistical analysis of the historical data show that the total phosphorus concentration in the epilimnion (upper layer) and the hypolimnion (lower layer) has **not significantly changed** since monitoring began in **1991**. Specifically, the total phosphorus concentration in the epilimnion and hypolimnion has **fluctuated** but has not *continually increased* or *decreased* since monitoring began. (Note: Please refer to Appendix E for the statistical analysis explanation and data print out.)

One of the most important approaches to reducing phosphorus loading to a waterbody is to continually educate watershed residents about its sources and how excessive amounts can adversely impact the ecology and value of lakes and ponds. Phosphorus sources within a lake or pond's watershed typically include septic systems, animal waste, lawn fertilizer, road and construction erosion, and natural wetlands. If you would like to educate watershed residents about how they can help to reduce phosphorus loading into the lake/pond, please contact the VLAP Coordinator.
